# **NOVATO**

### **Investigation Analysis of the Cedar Fire Incident**

**Engine 6162 Crew Entrapment,  
Fatality, and Burn Injuries  
October 29, 2003**

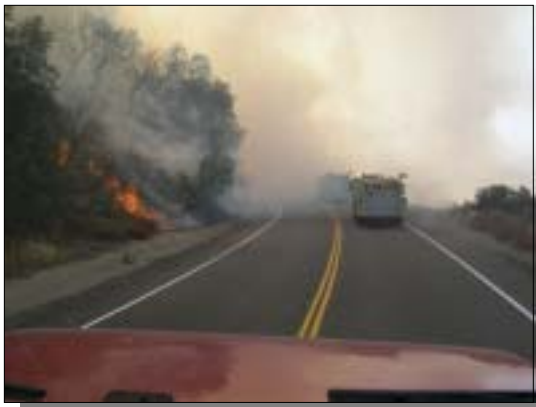
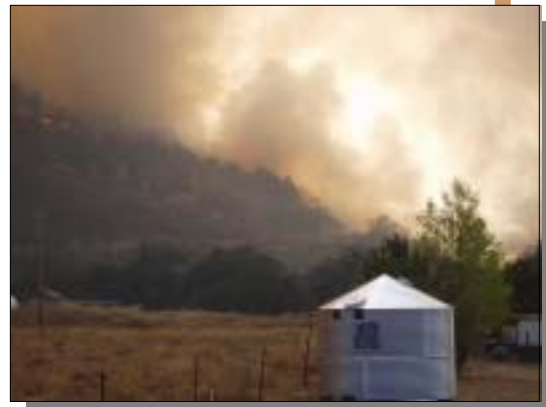
*(Right) Slop over Fire after it crossed Highway 78/79 viewed from Santa Ysabel at 9:47 a.m. on 10/29/03 by crew of Engine 6162 . (B. Smith) (Left) Engine 6162 takes photos as they go through the slop over area. (B. Smith)*

At 9:47 a.m., the Task Force observed, according to Captain McDonald, that the fire had crossed Highway 78/79 between Santa Isabel and the Inaja Memorial. (See photo on right) According to Captain McDonald, he could see engines backing down Highway 78/79 in this area to avoid the fire that had crossed the highway. By about 10:20 a.m. the Task Force was assigned to do structure protection in the Riverwood Estates. Captain McDonald expressed his concern about passing through the area where the fire had recently crossed Highway 78/79; however, the Task Force was able to pass through this area without incident.

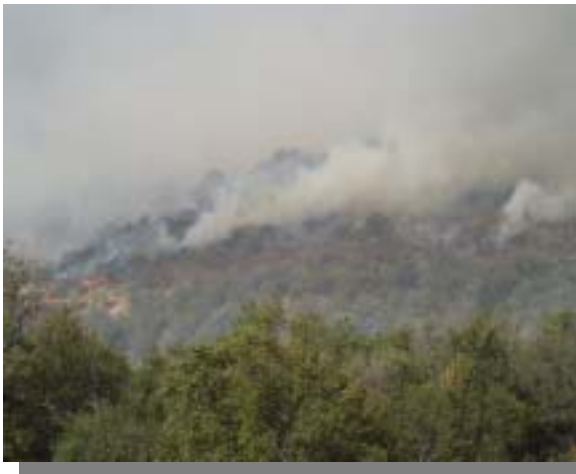
*Looking west from Riverwood Estates towards the slop over above Highway 78/79 at 10:56 A.M. on October 29, 2003. (B.Smith.)*

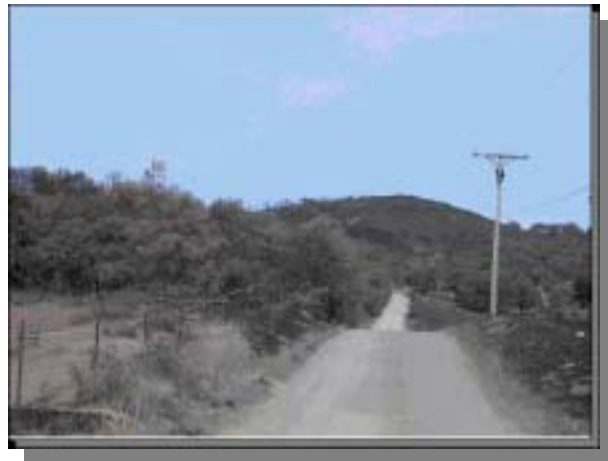
*Post fire view from south to north of Orchard Lane. Vehicles parked on side of the road are located just to the south of the driveway at 930 and 920 Orchard Lane.*

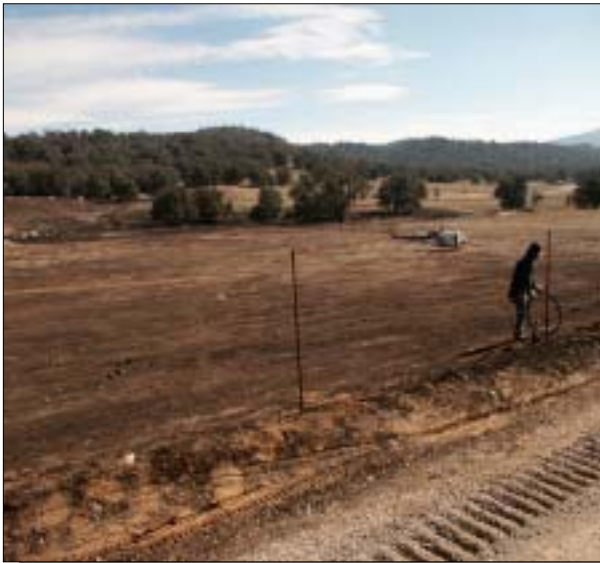
*Post fire photo of the grazed field identified as a Safety Zone by Engine 6162 crew. (D. Northern)*

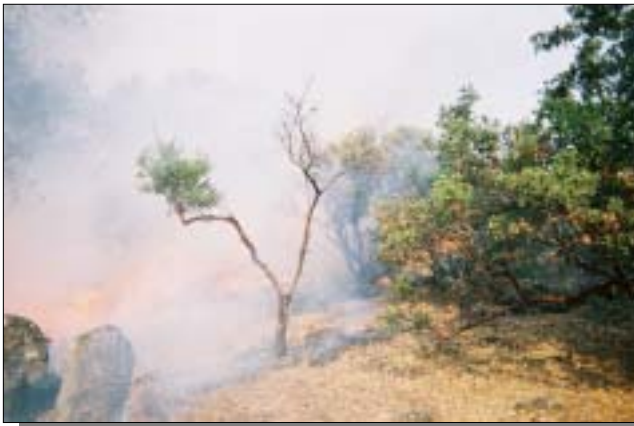
*Fire on the ground north of the garage just before Kreps begins to fire out from this location. This is the same area where Capt. McDonald saw a CDF Captain that appeared to be preparing to conduct a firing operation from the top of the driveway. View is to the north towards 902 Orchard Lane (S. Kreps)*

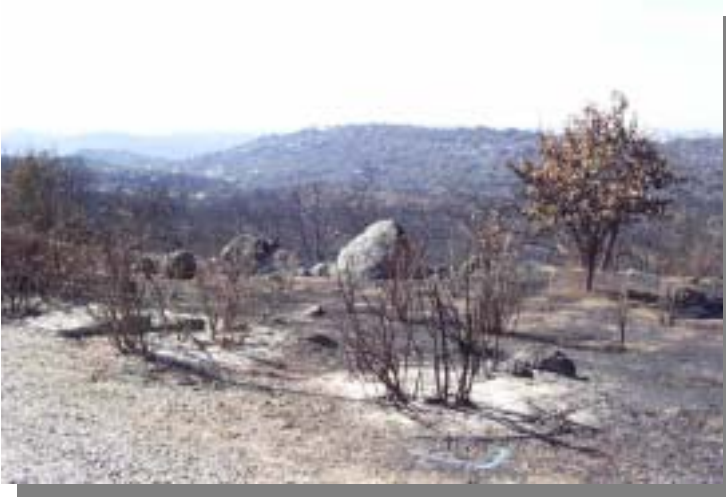
*Area below and to the southwest of Engine 6162 where brush had been cleared and crew strip burned grass stubble. Capt. McDonald threw fusees into brush below clearing. (R. Lopez)*

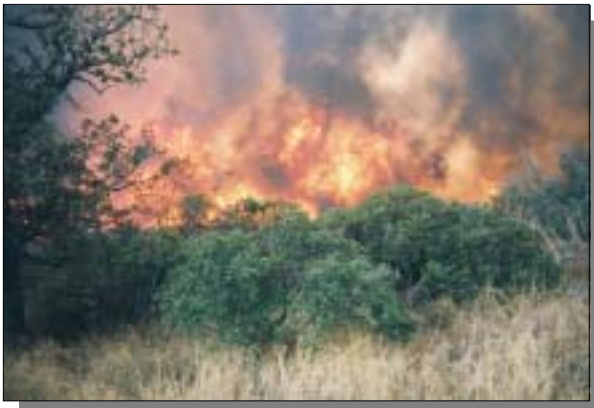
*Photo of the fire picking up over 140' below Engine 6162 just as the crew begin to return to the engine from firing out the stubble grass. (S. Kreps)*

Engineer Kreps had to wait for several minutes to take the photo to the left because the primary fire activity at this time was isolated torching in the brush. In this picture minimal wind activity is observed and the smoke and flame are standing straight up indicating a minimal wind influence.

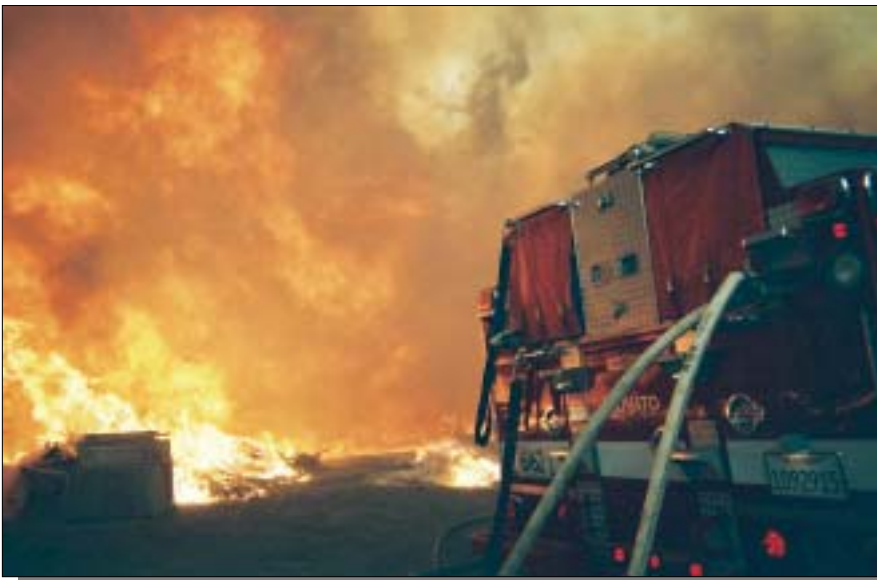
In the Kreps photo (left), taken from the rear of the engine, the burn pile can be seen beyond the engine. Fire activity at ground level as well the smoke appeared to be drawn to the South or Southwest. The engine was sitting on a flat driveway but the hose strap on the driver's side rear appears to be drawn away from the engine. Because the general wind conditions at the time were from the west there appears to be a local wind

*Behind the cover of the passenger side of the engine. (S. Kreps)*

condition or drawing effect influencing the conditions around the crew of Engine 6162 . The sun was now above them and to the south. The convective column appeared to blocking out the sun at this moment. The fire approaching from the south or southwest, as described by Captain McDonald, can be seen in the reflections on the back of the engine.

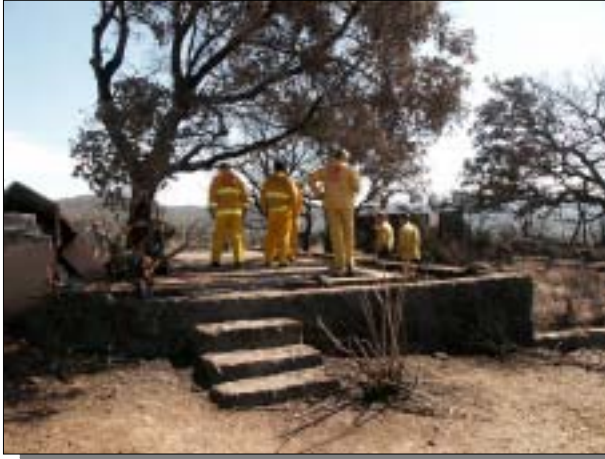
*A post incident photo showing Steps leading up to patio. Path which crew members used to get up onto the patio. (D. Northern)*
