# **NOVATO**

### **Investigation Analysis of the Cedar Fire Incident**

**Engine 6162 Crew Entrapment,  
Fatality, and Burn Injuries  
October 29, 2003**

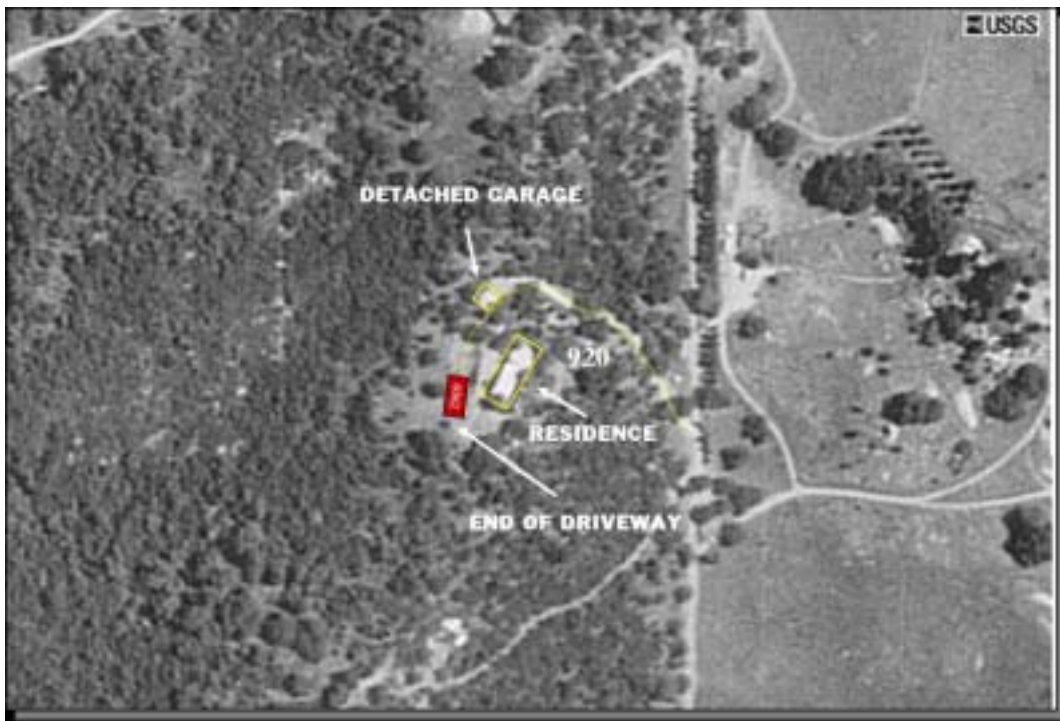
*Area below and to the southwest of Engine 6162 where brush had been cleared and crew strip burned grass stubble. Capt. McDonald threw fusees into brush below clearing. (R. Lopez)*
